NRL/MR/7130--03-8685

Preliminary Observations Regarding LDV Scans of Panels Excited by Broadband Actuators at the U.S. Capitol

*Physical Acoustics Branch
Acoustics Division*

November 7, 2003

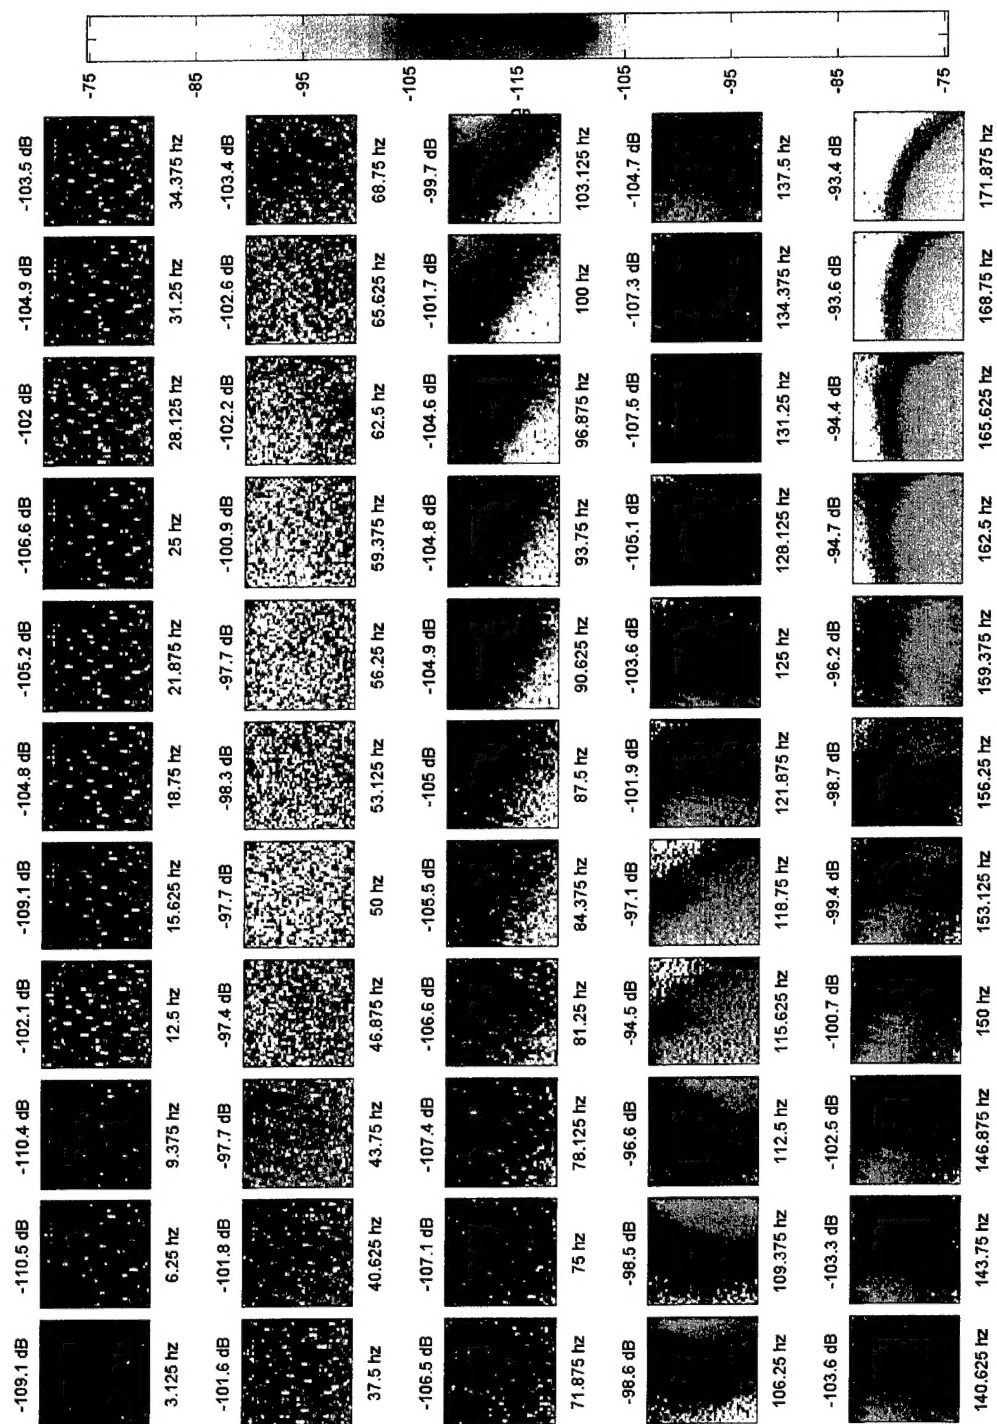
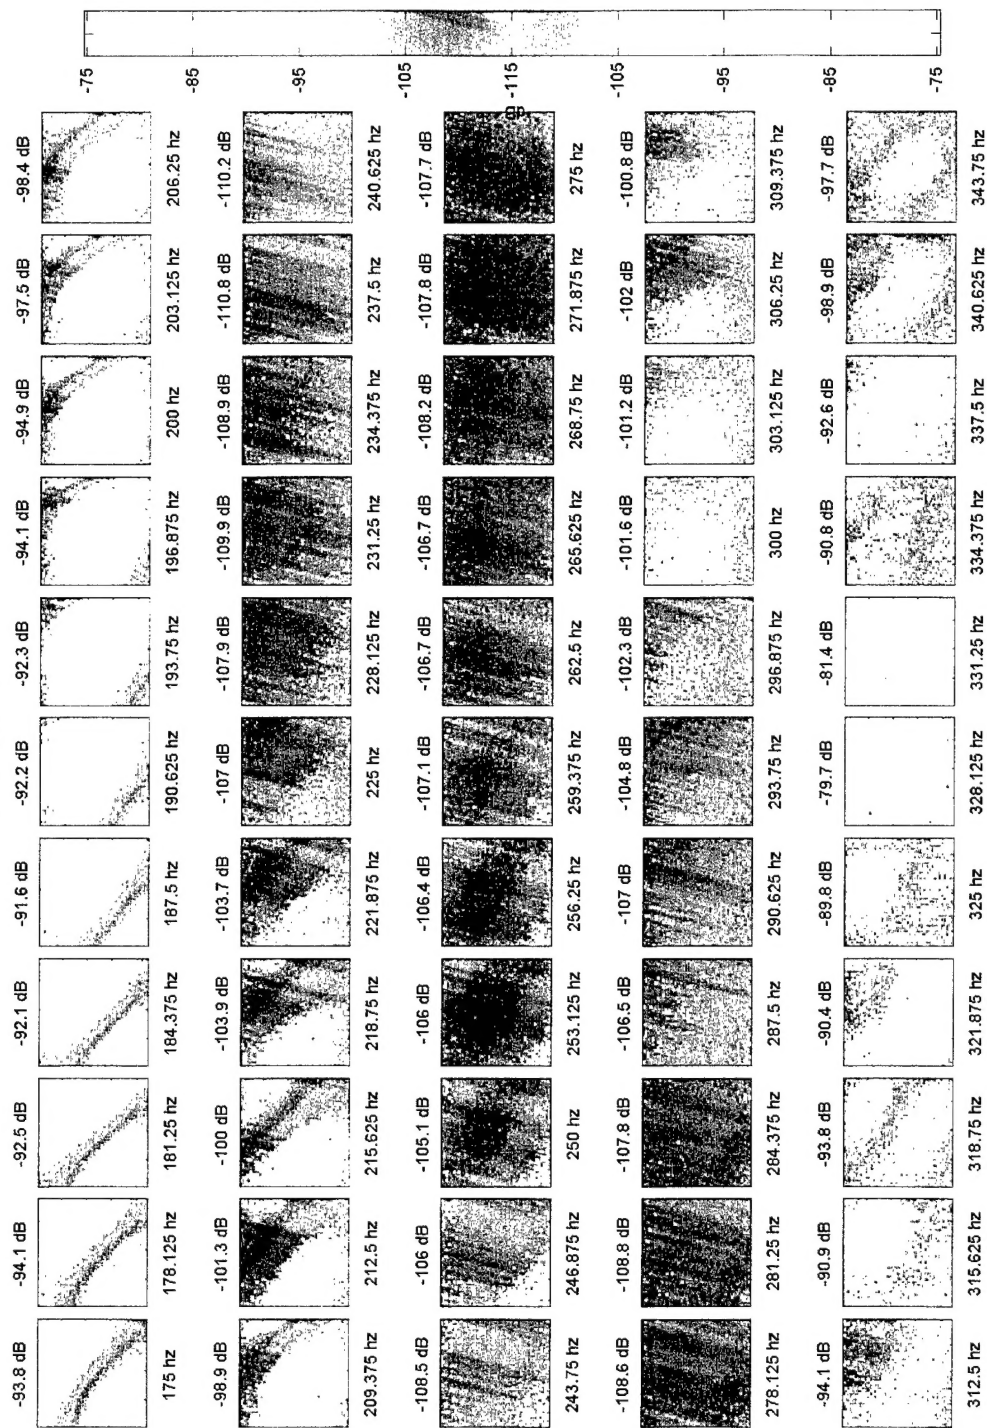
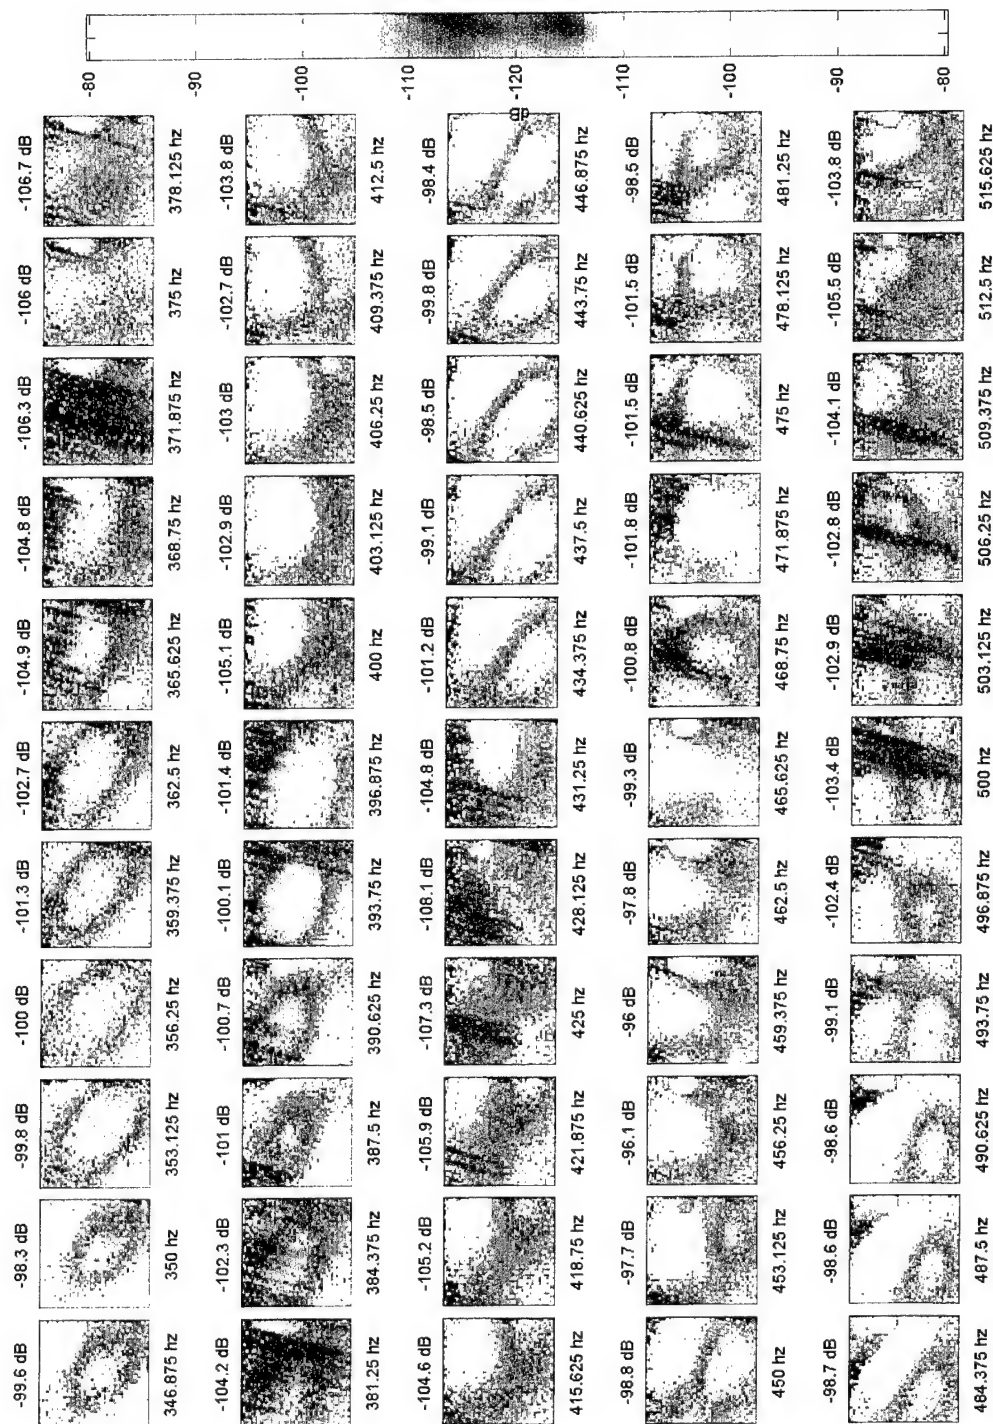
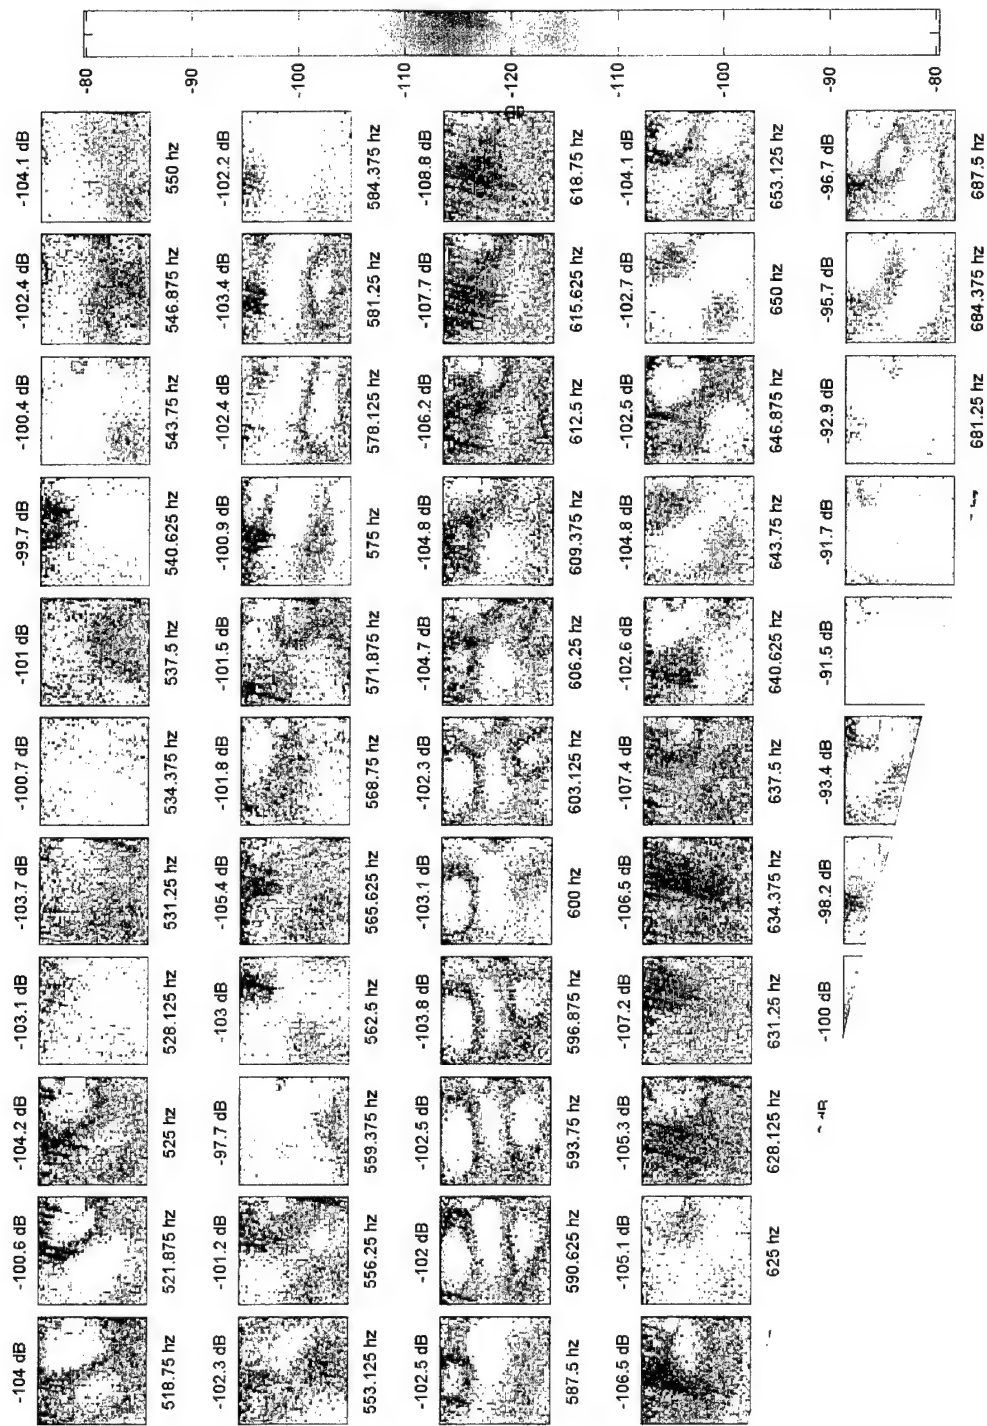
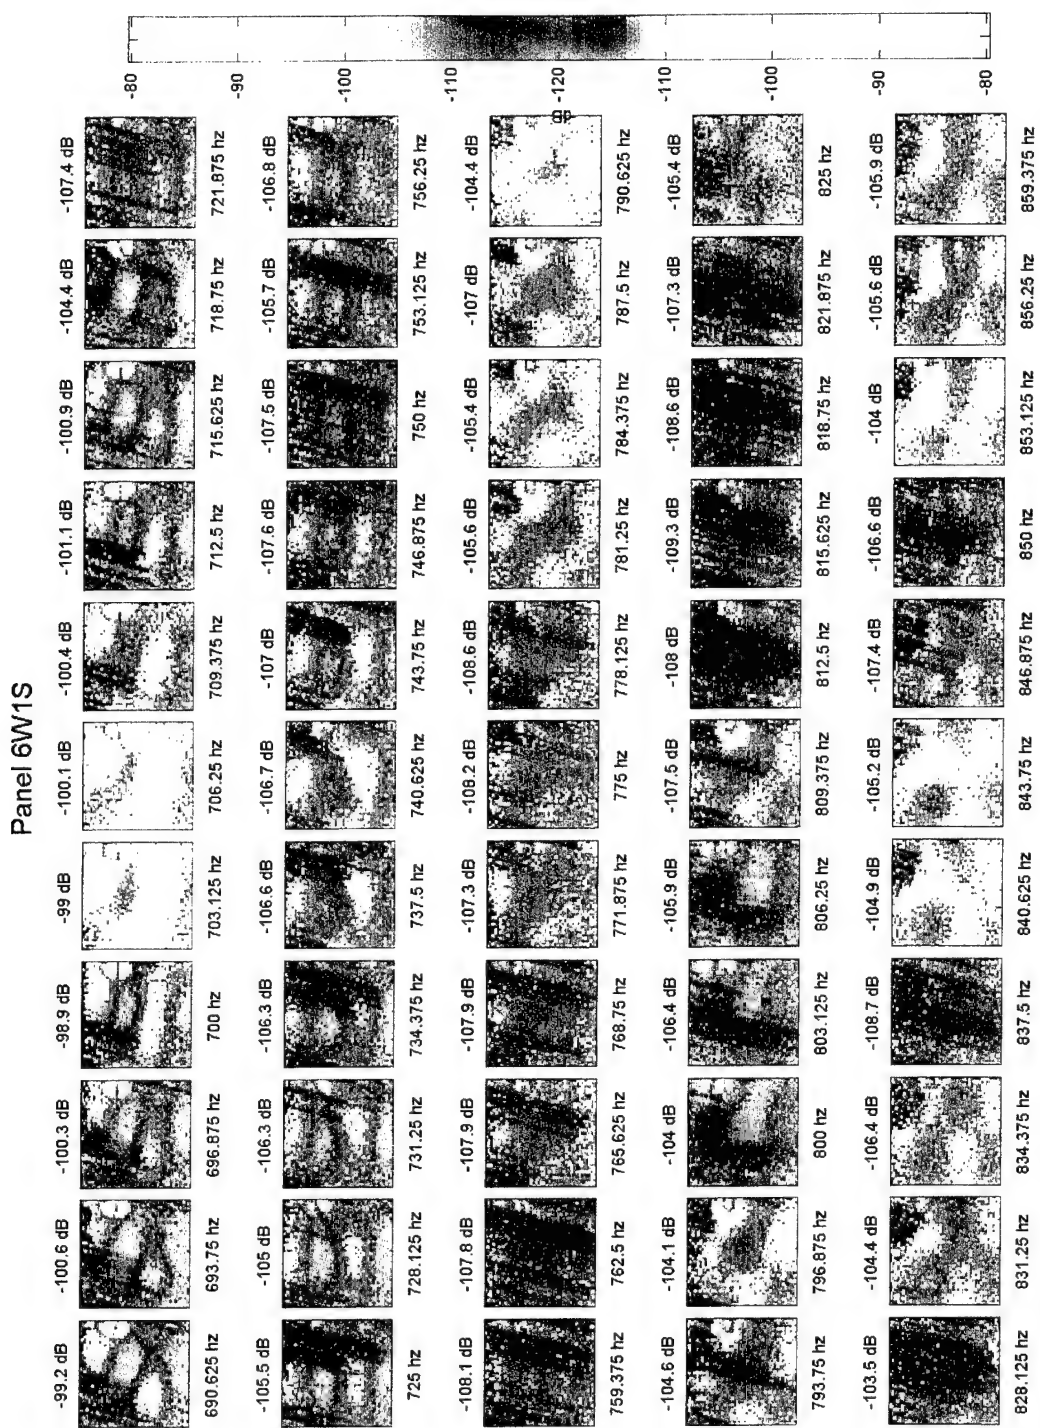
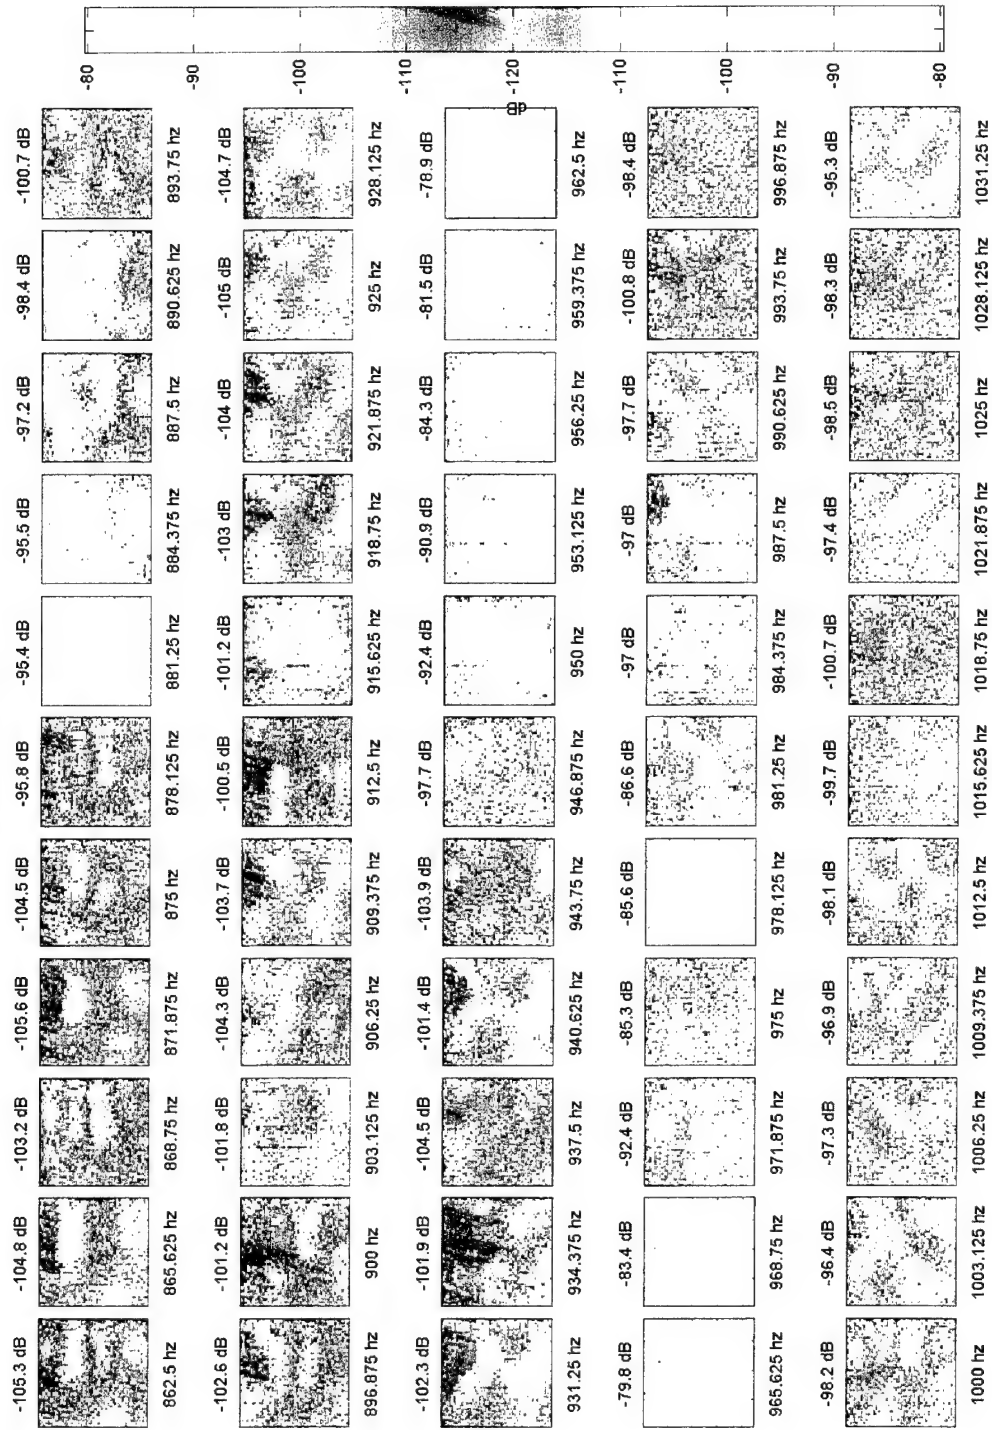
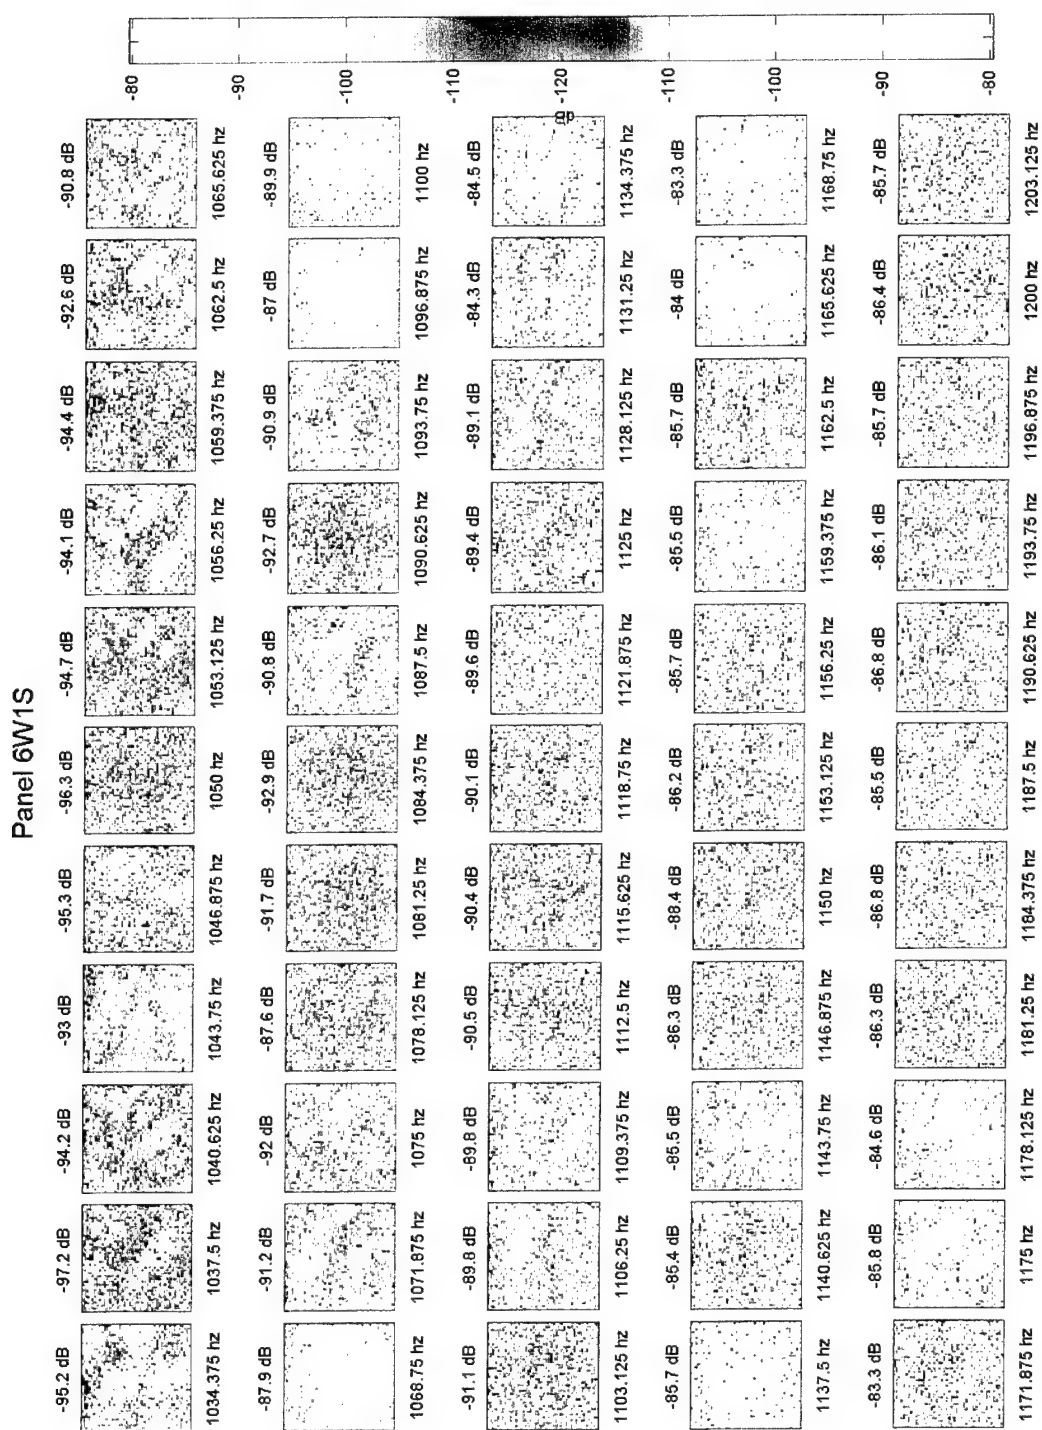
We first discuss the measurements taken on Panel 1 (see Fig. 1). Simple sequential observations (see Figs. 2a - 2g and Figs. 3a - 3f) of the velocity scans (phase and amplitude) at each three Hertz increment indicate that we have obtained meaningful data on panel 1 over the band from about 80Hz to 1KHz. From 80Hz to about 400 Hz we can observe what appears to be simple wave propagation from the lower left corner where the actuator is located up toward the upper right hand corner. This seems especially clear from the phase plots. The wave speed is very crudely estimated to be about 700 m/sec over this lower band, suggesting shear wave propagation in the plaster. Beginning just below 400 Hz one can see even higher motions over a smaller patch size (about 18cm by 26 cm) near the right edge just above the scanned panel center. It appears strongest at about 460 Hz and seems to fade in and out with something like a 25-40 Hz period. At about 670 Hz, the motion over this patch breaks into a two-lobe mode pattern. Both the extent and location of this mobile patch coincides with a defect area discovered earlier in the tap test data. We should point out, however, that the same tap test data seems to indicate another defect area on the left, a location where we do not see any obvious localized high levels of motion in the LDV maps in this frequency band.
